# Identifying and Fixing Hardware & Software Faults

Unit 13: P4, P5, P6, M2, M3; Partially covers P2

Unit 25: P5, P6, M2, M3, D1, D2; Partially covers P4

Richard Hancock

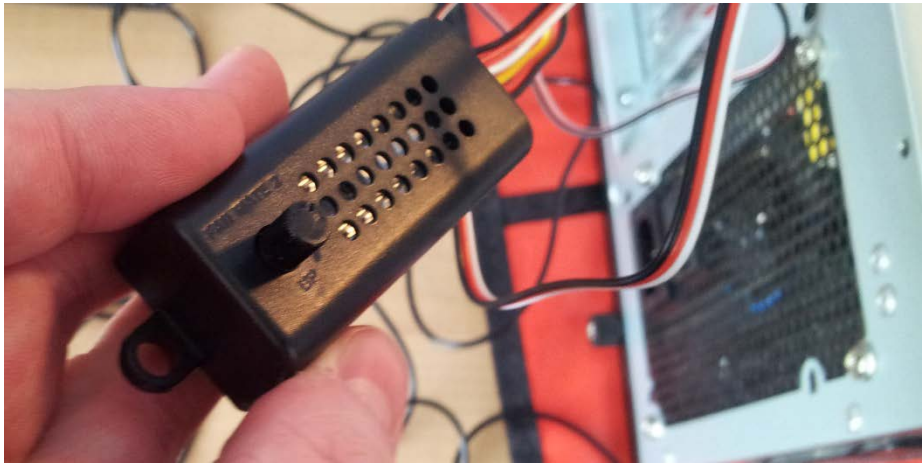
I attached the Fan controller to the side which does leave the wires running along the outside of the case quite a distance. Some tape could cover this wire, or drilling a hole closer to the fan controller. However there no danger in leaving them like this unless they get damaged.

*Fan controller with cables attached.*

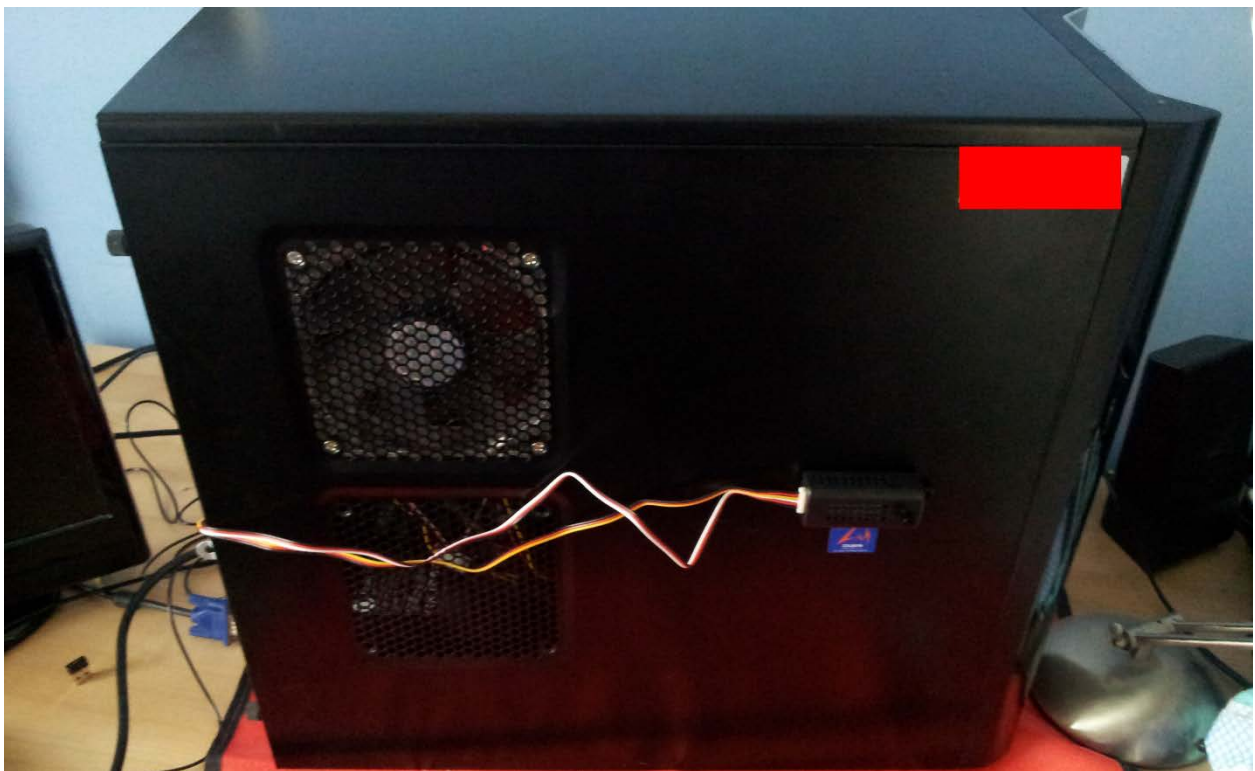
*Picture from much later in the repair process with the fan controller on the side, and the less than ideal cable run.*

The user could also later invest in a more expensive fan controller that will fit in a CD drive bay, so there would be no exposed wires.

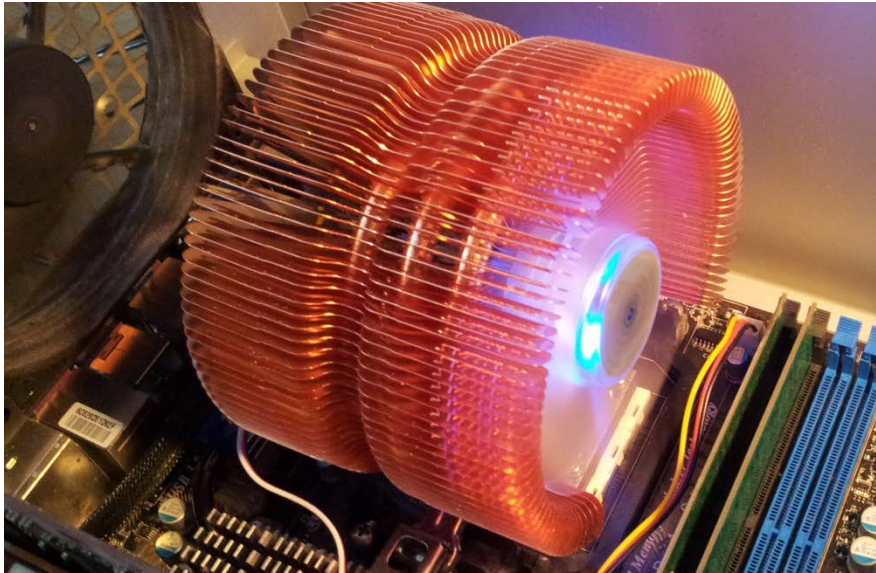
*Fan lit up in blue and rotating*

After waiting a few minutes for the computer to boot up, I opened the CPUID HWMonitor to check the temperature, and there was a very noticeable difference of around 30-40°C

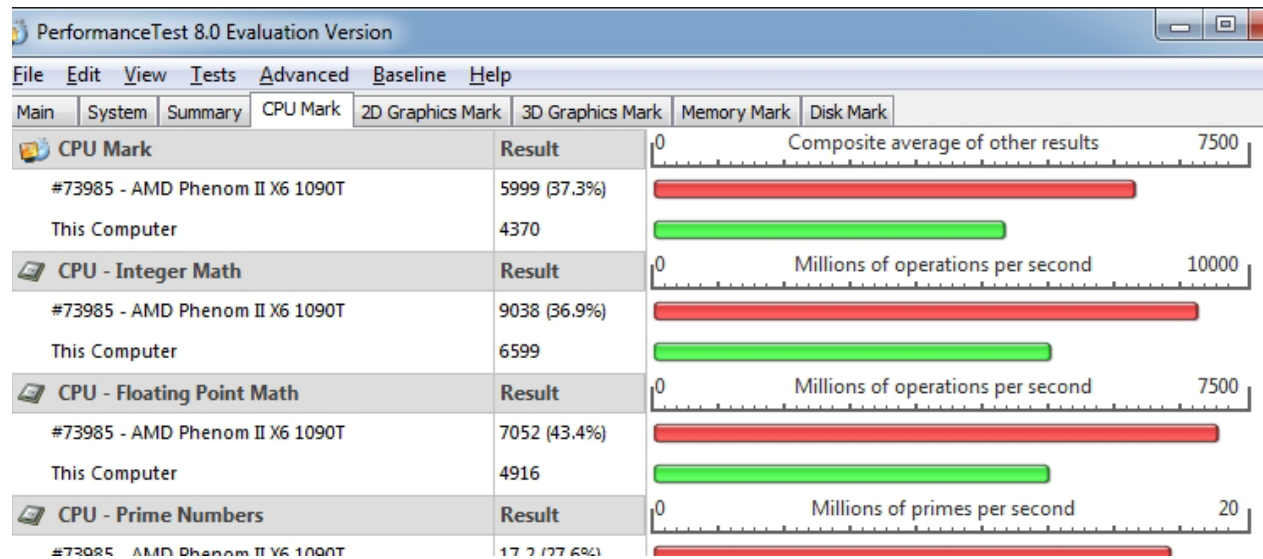
These results show no major difference in performance from the previous tests 4381 and this tests 4370. I then decide to update the Graphics driver because this includes the AMD Catalyst Control Centre, which can control the CPU as well as the GPU.

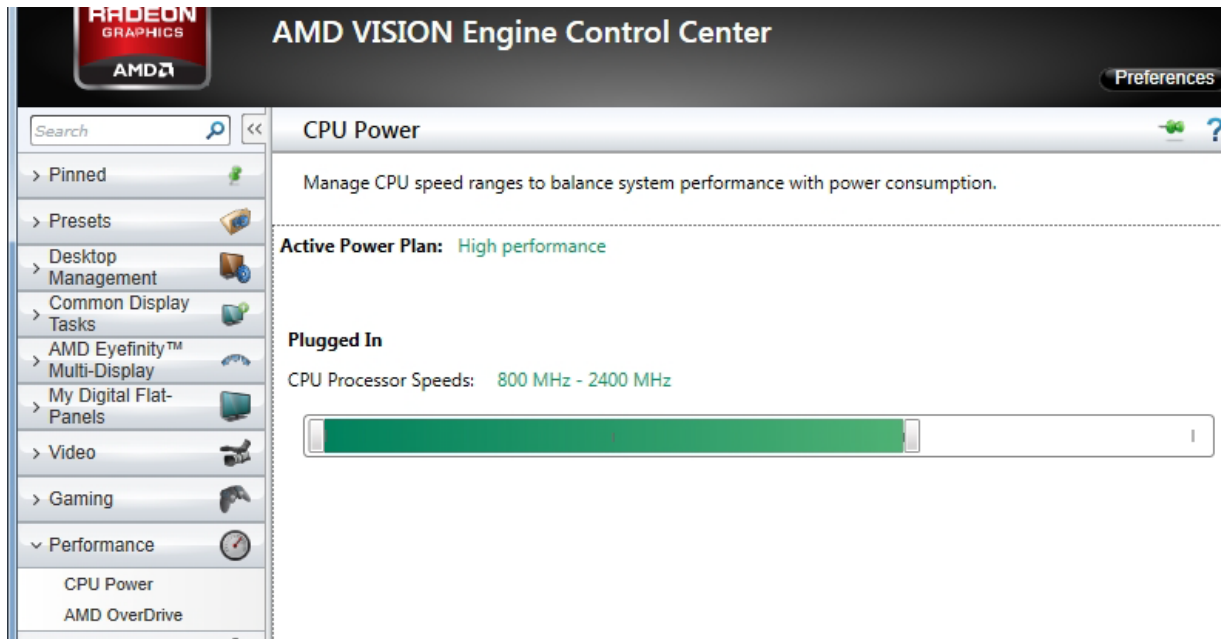
CPU Power Screen

The CPU had been under-clocked previously to 1/3 of its capability, probably to try to combat the overheating problem. So I increased the slider to the max and restarted the computer.
